# Manhole Inspection Summary

Manhole # S41AA\_018MH

Insp Date: **8/6/08 11:20 AM**

**Location** Address: **725 mello ct**

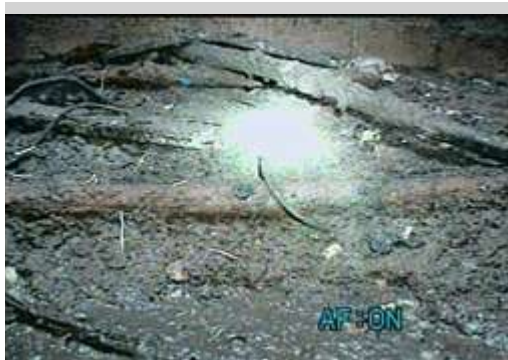
Defect 5

Condition: ☐ Sound ☐ Cracked ☐ Root Intrusion ☐ Deteriorated ☐ Leaks ☒ **Debris**

channel debris

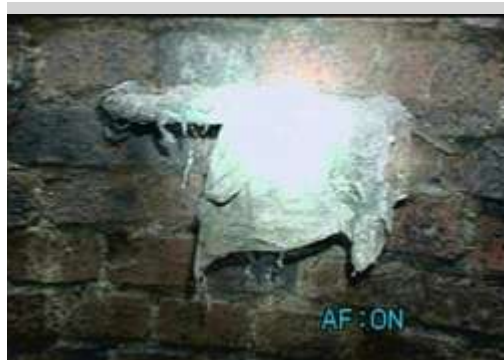
Defect 4

☒ **Evidence Of Surcharge** Depth: **2.3** (ft.) ☐ Active Surcharge Present

evidence of surcharge

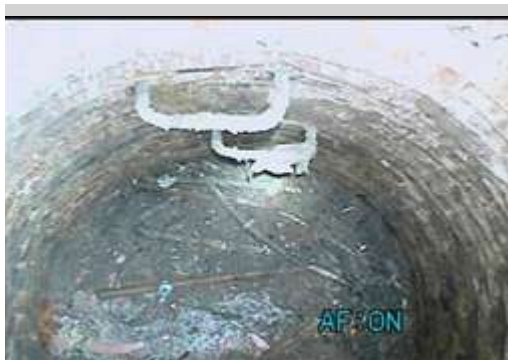
Defect 3

Count: **2** Missing: **0** ☒ **Corroded**

steps

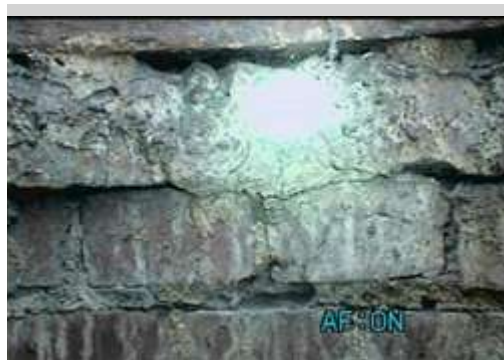
Defect 2

Condition: ☐ Sound ☒ **Cracked** ☐ Root Intrusion ☐ Loose Brick ☐ Deteriorated

crack in corbel

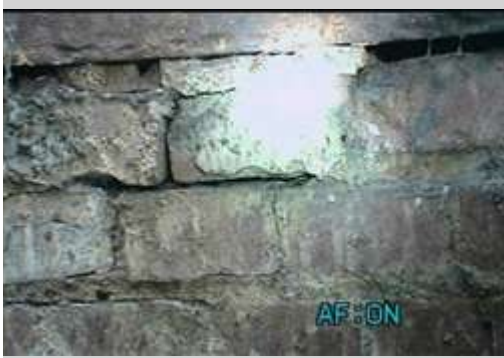
### Defect 1

Condition: ☐ Sound ☐ Cracked ☐ Root Intrusion ☒ **Loose Brick** ☒ **Deteriorated**

cracked, loose bricks, deteriorating  
chimney, frame adj
